TECHNICAL REPORT D-77-23

HABITAT DEVELOPMENT FIELD INVESTIGATIONS WINDMILL POINT MARSH DEVELOPMENT SITE JAMES RIVER, VIRGINIA

SUMMARY REPORT

August 1978

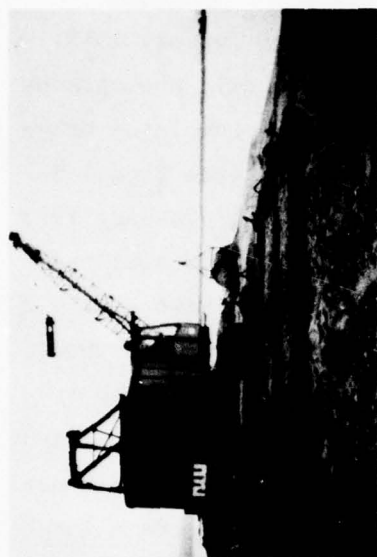
b. DRAGLINE FILL CONSTRUCTION

c. COMPLETED DRAGLINE FILL ALONG
NORTH DIKE ALIGNMENT

a. DRAGLINE FILL CONSTRUCTION SCHEDULE

Figure 6. Construction of dragline fill dike section during the period 15 to 20 January 1975

38. Construction of the dragline fill section (Figure 6) was done by Higginson-Buchanan, Inc. under subcontract to Merritt Dredging Company. Dragline fill placement was initiated on 15 January 1975 on the east dike alignment and progressed continuously along the hydraulic fill section to completion at the southeast corner on 20 January 1975. In Figure 6 are shown the construction schedule (Figure 6a), photographs of dragline fill placement operations (Figure 6b), and a completed dragline fill section (Figure 6c). Fill was placed to elevations from 1.8- to 2.4-m CELW. Dragline fill cross-sections surveyed on 17 January 1975 are shown on Figure 5 as superimposed on hydraulic fill cross-sections surveyed on 8 to 9 January 1975. Dike settlement problems were experienced during dragline fill construction. On several occasions, vibration during dragline movement caused recently placed fill to settle excessively. Settled sections were immediately repaired by placing additional fill. Repaired sections tended to remain stable during additional dragline movement. However, dike settlements continued at certain locations requiring treatment as discussed in the following section.

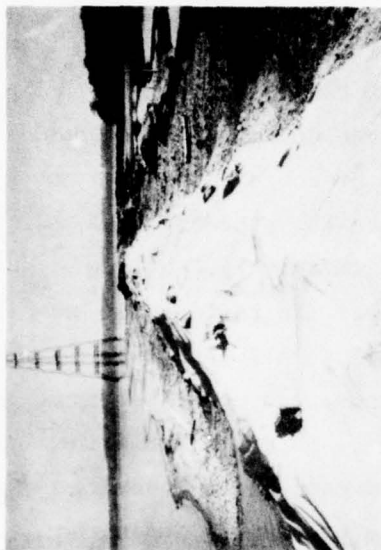
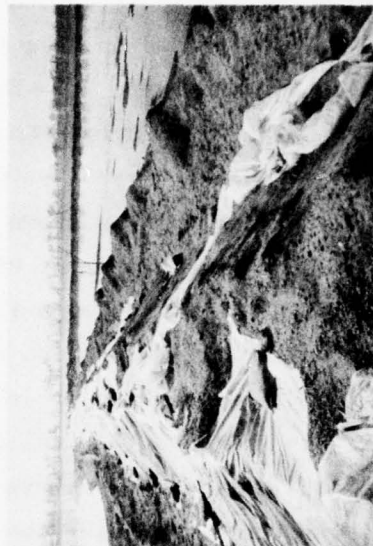
a. DIKE LENGTHS COVERED WITH POLYETHYLENE SHEETING
ON 21-22 JAN 1975

b. POLYETHYLENE SHEETING - NORTH DIKE ALIGNMENT, 23 JAN 1975

c. DAMAGED POLYETHYLENE SHEETING - WEST DIKE ALIGNMENT
28 JAN 1975

Figure 7. Polyethylene sheeting used for erosion protection

fill section was to be graded after a 4- to 5-month period of dredged material consolidation and marsh establishment. The polyethylene sheeting was installed on 21 through 22 January 1975 along the north and west dike alignments as indicated in Figures 7a and 7b. However, sand bags used to anchor the polyethylene sheets provided to be inadequate. Wind and water forces displaced the polyethylene sheets at many locations as shown in Figure 7c. Erosion of the dragline fill slopes was a continual problem during and after the dredging operations.

42. Dike erosion and settlement continued during disposal operations. The poorly installed (and subsequently damaged) polyethylene sheeting was largely ineffective in preventing erosion of the dragline fill slopes. Erosion of exterior slopes was predominant during high tide periods. Interior turbulence flow velocities generated by the dredged material (slurry) discharge caused significant erosion of interior slopes during disposal operations. Erosion of the dragline fill section continued after dredging and disposal operations were completed.

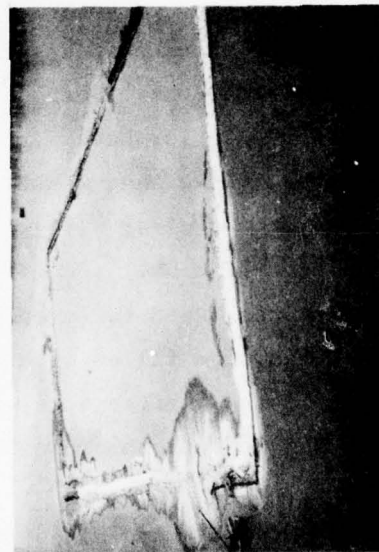
a. BREACH LOCATIONS

b. REPAIRED BREACH ON NORTH DIKE ALIGNMENT, 24 JAN 1975

c. BREACH ON SOUTH DIKE ALIGNMENT, 24 JAN 1975

d. REPAIR OF BREACH ON SOUTH DIKE ALIGNMENT, 26 JAN 1975

Figure 8. Dike breaches repaired during 22 through 26 January 1975

40. Excessive dike settlement resulted in breaches along the north and south dike alignments as shown in Figure 8a. The breached section along the north dike alignment was approximately 76.2-m long and was reported to have settled 0.9 m in one day. The rapid subsidence indicated that an embankment-foundation shear failure had occurred. Personnel directly involved in the project and engineers consulted from the Savannah District examined the failed section. Detailed field investigations and analyses of the failure were not conducted; however, site observations and review of dike construction procedures indicated that failure was likely caused by development and entrapment of foundation mud waves during hydraulic fill construction. Hydraulic fill placement normally causes mud waves to form as soft foundation soils are displaced. Mud wave material is generally weakened in its remolded or disturbed condition and may not provide adequate support when trapped beneath the hydraulic fill. Entrapment of mud waves is a common problem at hydraulic fill tie-in or closure locations. The breach in the north dike alignment corresponds closely to the 91.4-m gap near the northwest corner, which was closed on 15 January 1975 (Figures 4a and 4c). Earlier hydraulic fill placement at both ends of the gap could have generated mud waves that were later covered with hydraulic fill during final closure on 15 January 1975.

41. The breached dike sections on the north and south dike alignments (Figure 8a) were repaired by placement of additional hydraulic fill (sand) obtained from the borrow area near Bucklers Point (Figure 2). In dike repair, the dredge discharge pipe was supported on elevated cribbing along the centerline of the breached sections. Fill material was discharged from the end of the pipe and from bleeder holes in the

underside of the pipe. Hydraulic fill was placed to design elevation (5.7-m CELW) without additional working by dragline. The repaired breach on the north dike alignment is shown in Figure 8b. The breached section on the south dike alignment and subsequent hydraulic fill repair work are shown in Figures 8c and 8d, respectively. Dike repair was completed on 26 January 1975. Channel dredging and disposal into the habitat site was continued on 27 January 1975.

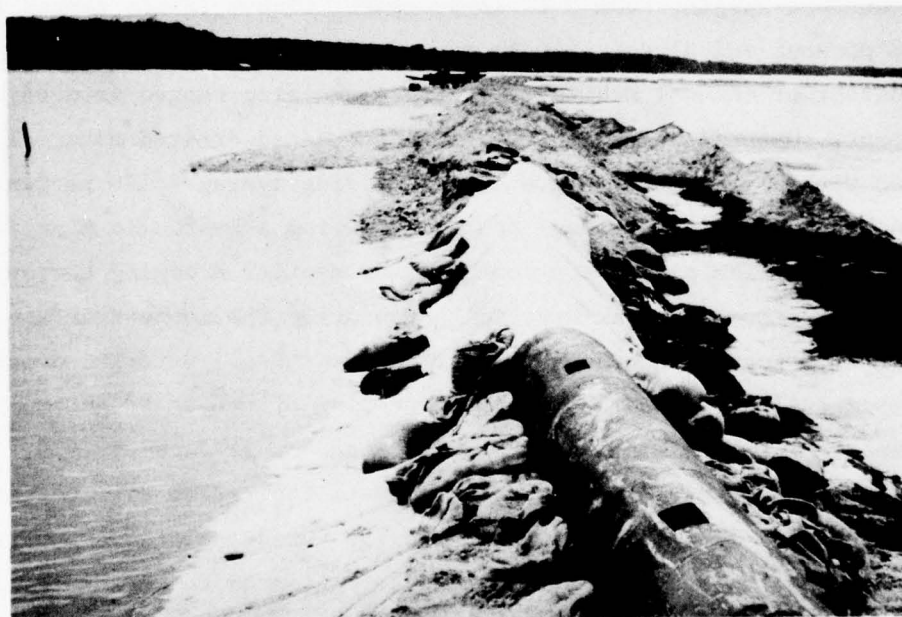
a. LOCATION OF BREACH

b. REPAIRED BREACH, 29 JAN 1975

Figure 9. Dike breach repaired during the disposal operations, 27 Jan-4 Feb 1975

43. Dike settlement was concentrated along the eastern half of the south dike alignment. An approximately 61-m long breach developed near the southeast corner as shown in Figure 9a. Dike repair was accomplished by placing dredge pipe sections, polyethylene sheeting, and sand bags across the settled zone as shown in Figure 9b. Seepage through the dike was observed along the repaired section and several other locations along the south dike alignment. Seepage was predominant during low tide periods when interior-exterior head differential was a maximum (approximately 0.6 to 0.8 m). Dike sand was very soft at seepage exit locations, however, seepage water was clear with no indication of subsurface erosion or piping within the dike. Localized minor settlement along the south dike alignment continued to develop throughout the disposal operations. Settled areas were filled with sand (or sand bags) as needed until disposal within the habitat site was completed on 4 February 1975. Dredging and disposal operations are discussed in the next section.

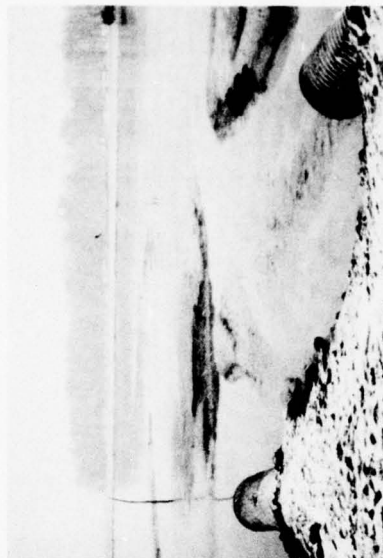
a. LOCATION OF DREDGE DISCHARGE AND EFFLUENT OUTLET PIPES

b. DREDGED MATERIAL DISCHARGE

c. EFFLUENT OUTLET PIPES

Figure 10. Dredged material discharge in habitat development disposal site during the period 27 January to 4 February 1975

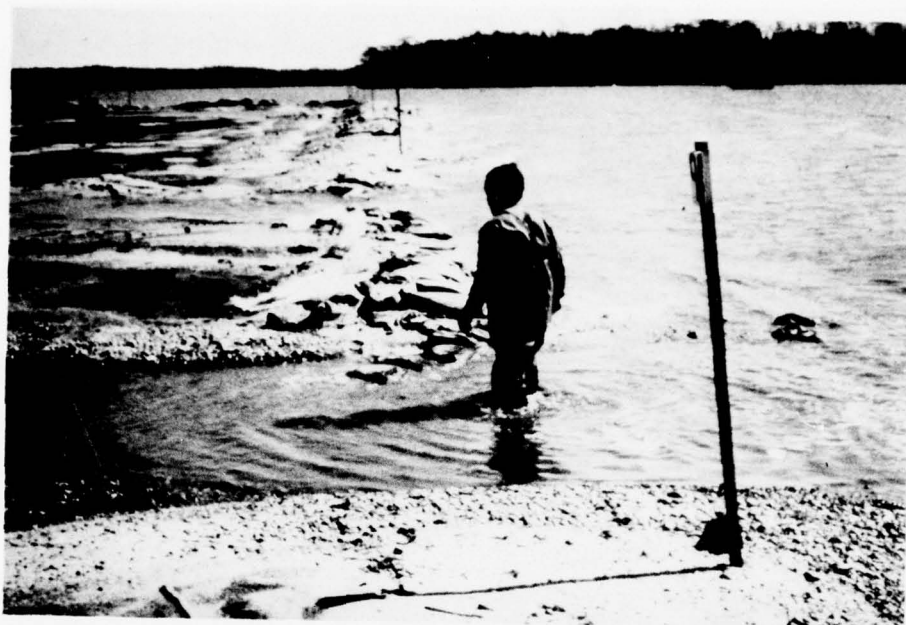
Figure 13. Breached section along south dike,
25 Mar 1975

two breaches developed that required repair. The breaches, shown in Figure 13, were 3.0 to 4.6-m wide and were located along the south dike alignment in an area that had previously settled and been repaired during dredging operations (Figure 8). Plywood sheets and sand bags were placed to repair the breached sections. This section breached again 1 to 2 months later, but was left unrepaired to facilitate intertidal water circulation within the site.

52. Costs of engineering operations are summarized in Tables 3 and 4. Costs of marsh development site design and construction are summarized in Table 3: total cost was \$202,693.30. This cost includes additional borrow area dredging conducted 22 through 26 January 1975 in repair of settled dike sections (Figure 8). However, placement of polyethylene sheeting (Figure 7) and dike repair during dredging operations (Figure 9) were absorbed in the contractor's dredging costs. Dike sections breached after completion of dredging operations (Figure 13) were repaired by Norfolk District personnel.

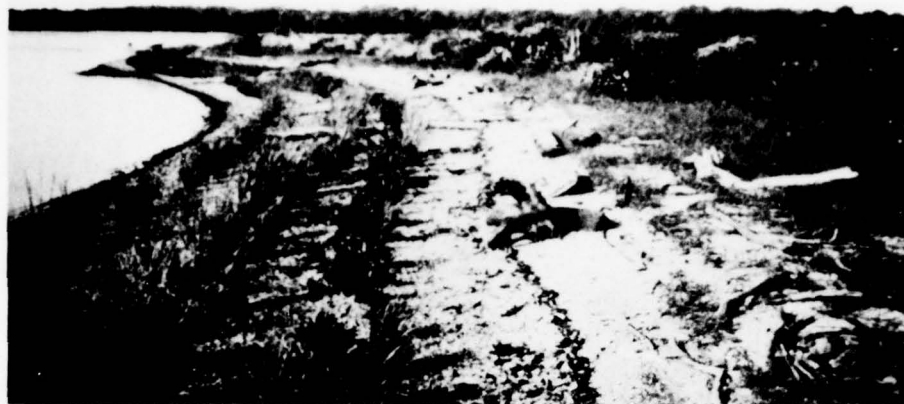
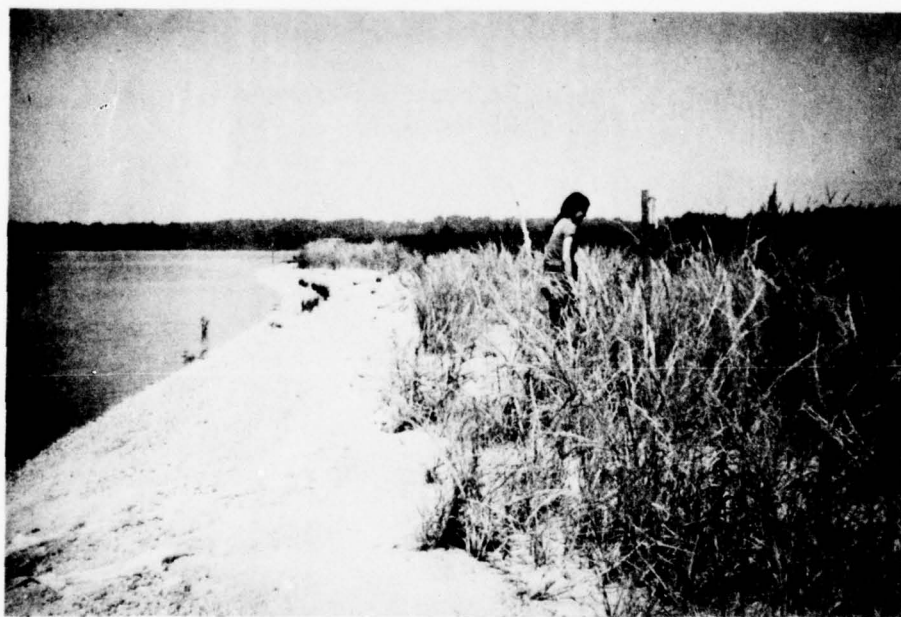
a. EXTERIOR SLOPE, OCT 1975

b. EXTERIOR SLOPES, SEP 1976

Figure 14. Plantings for exterior slope stabilization on the west dike

49. In July 1975, a small tractor was used to grade the remaining dragline fill section and portions of the hydraulic fill. Dredged material within the habitat site was not graded. After grading, marsh vegetation was propagated along the exterior (hydraulic fill) slopes to provide long-term erosion protection. Smooth cordgrass (Spartina alterniflora) plants were sprigged along the slopes in July 1975 and developed quite rapidly as shown in Figure 14a. However, these plants were ultimately destroyed by wave action and animal depredation. In September 1975 portions of the dike's exterior slopes did not support any vegetation as shown in Figure 14b.

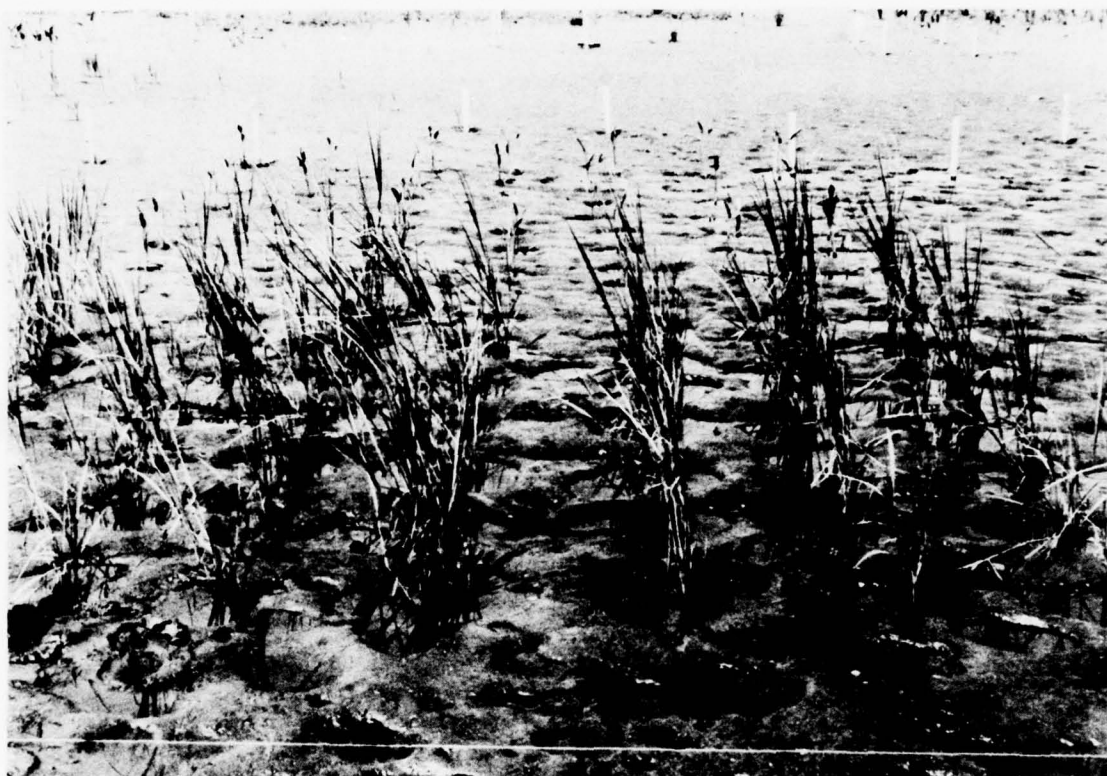
Figure 22. Animal excavations at the base of S. cynosuroides in sprigged plots as seen on 29 August 1975.

68. The successful trend changed abruptly, though, during August 1975 when many of the intertidal plantings were lost primarily to Canada goose grazing (Figure 22). Plants also were washed out by wave action that resulted from continual ship and barge traffic on the James River and by high current energies during periods of high water on the river. By 30 September 1976 only two out of 128 intertidal monotypic study plots remained with transplants growing on them. One of the remaining plots was sprigged with smooth cordgrass and the other with big cordgrass. These plantings continued to grow during the 1977 growing season but replacement of them by the invasion of willows (Salix nigra) appears quite possible by the next growing season.
